GP150M Pump Refurbishment

A Case Study

A detailed case study on the comprehensive refurbishment of a Sykes GP150M diesel pump. This project highlights our commitment to restoring critical equipment to peak performance, ensuring reliability and efficiency for our customers.

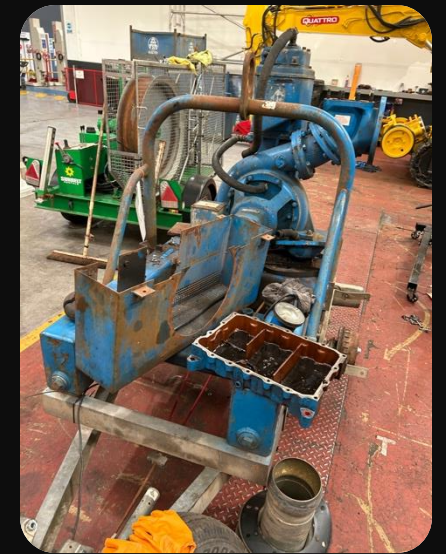
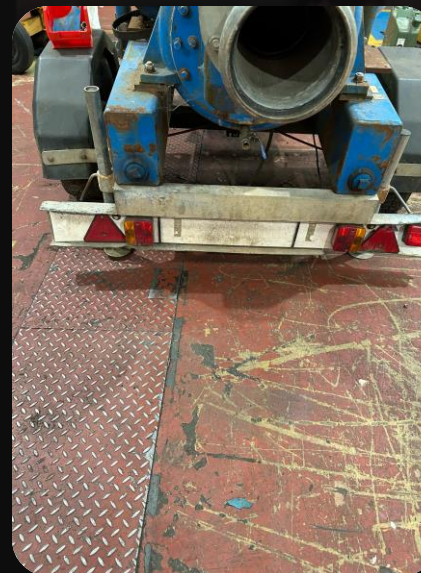
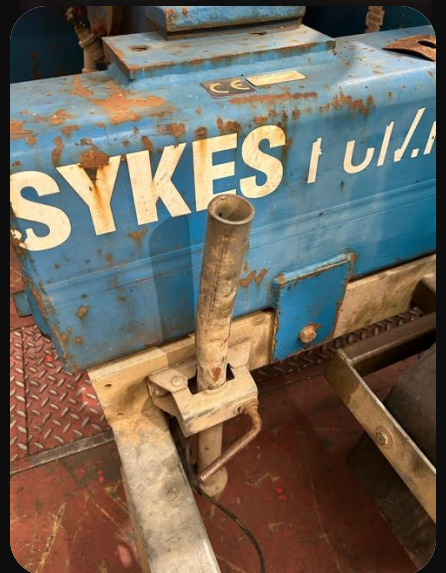
Our team undertook a complete overhaul of the Sykes GP150M pump. The project scope included a full strip-down, detailed inspection of all components, replacement of worn parts, and a complete rebuild to manufacturer specifications. The a full repaint and rebrand.

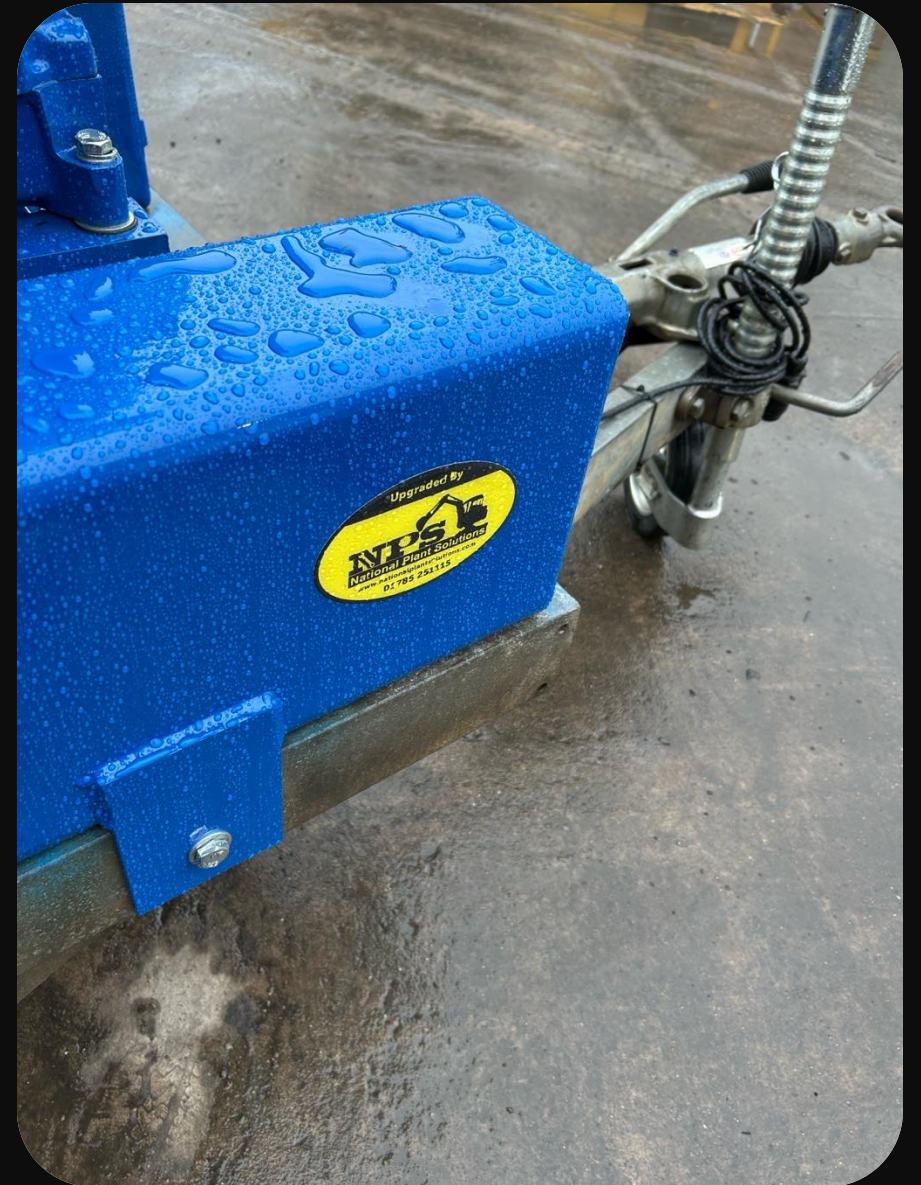
Phase 2: Inspection & Rebuild

Each component was dimensionally checked against manufacturer tolerances. The engine was rebuilt, the pump end fitted with new parts, and the unit was reassembled. Once complete a full refresh, repaint, rebrand was carried out.

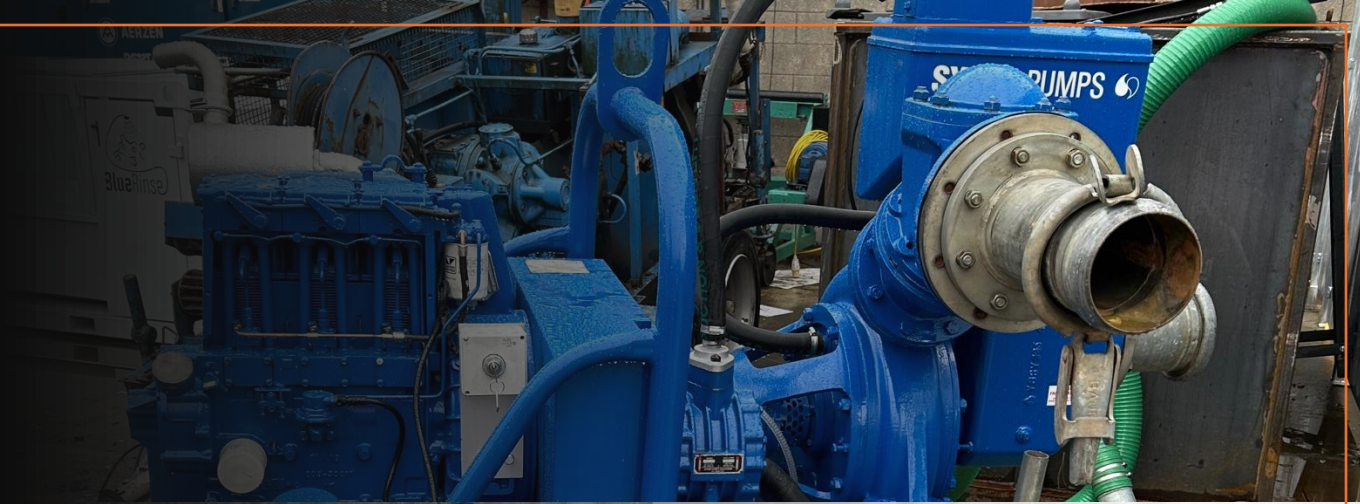
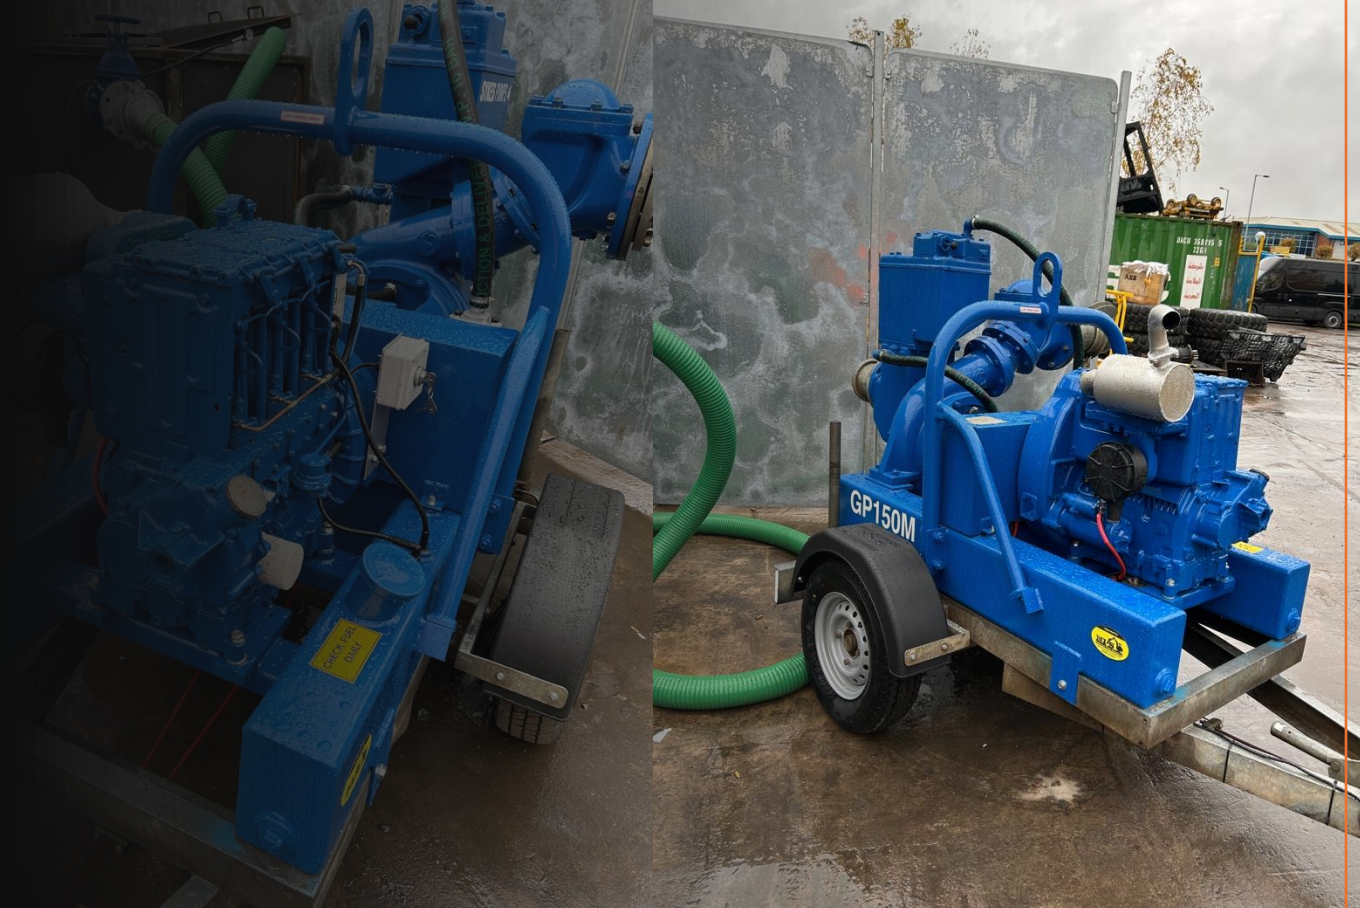
The result of our intensive refurbishment is a like 'NEW' return of a pump of 30yrs of age a true workhorse and reliable piece of equipment now given a new lease of life allowing to continue its reliability and functionality in supporting our valued customer...
